Voids at Cu / Solder Interface and Their Effects on Solder Joint Reliability

Manufacturing Technology Group
Cisco Systems, Inc.

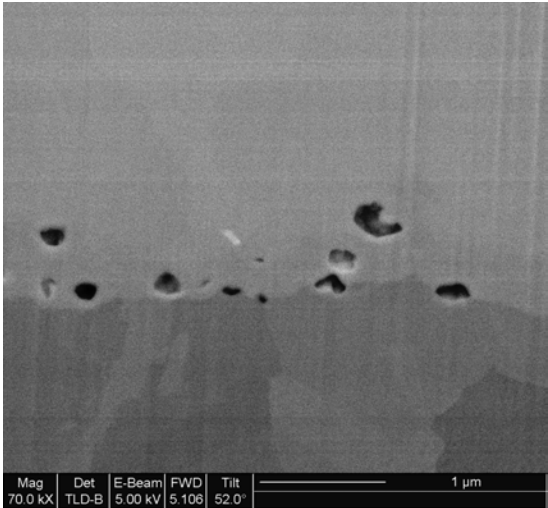
Voids are not tunnels, or pipes. They have about equal size in all three dimensions

One or two layer IMC?

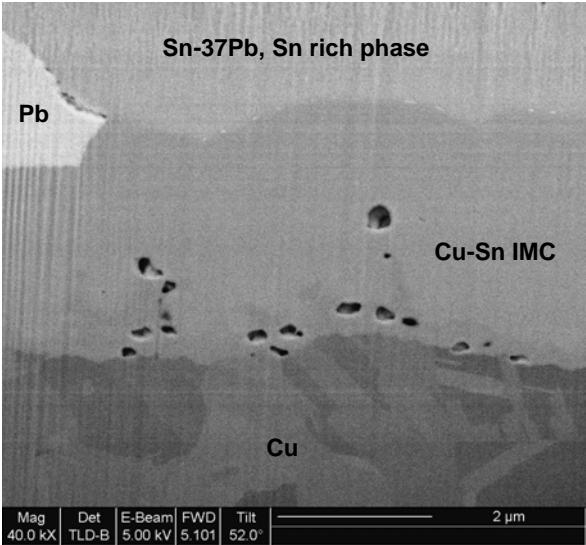
Voids are about 0.2 μm size, inside Cu-Sn IMC, close to Cu

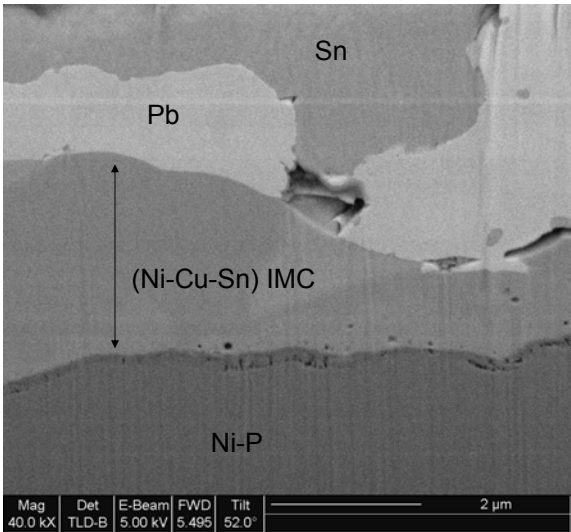
The Same Joint, but on Package Side: ENIG

-Some voids in the Ni-Cu-Sn IMC, and the P-enriched layer.

-The interface IMC contains Cu after baking, not before the baking.

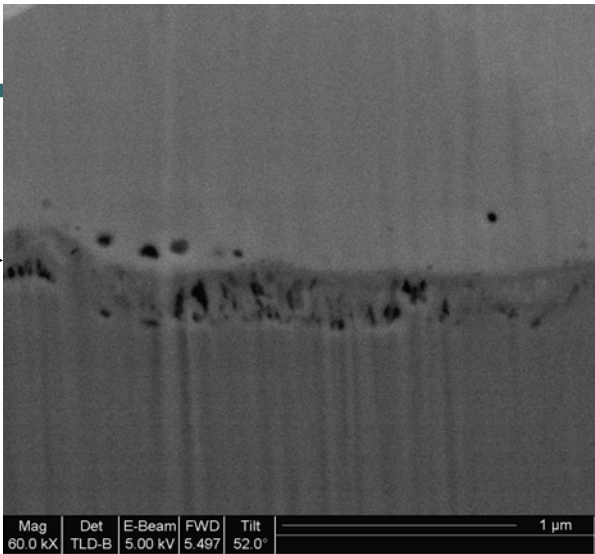
Voids are seen both inside the phosphorous enriched layer and inside the Ni-Cu-Sn IMC.

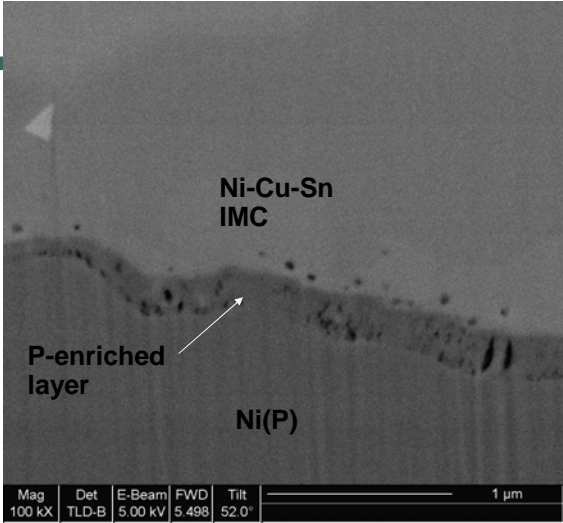
Another area. Most voids at ENIG side is much smaller in size, ~0.05 μm.

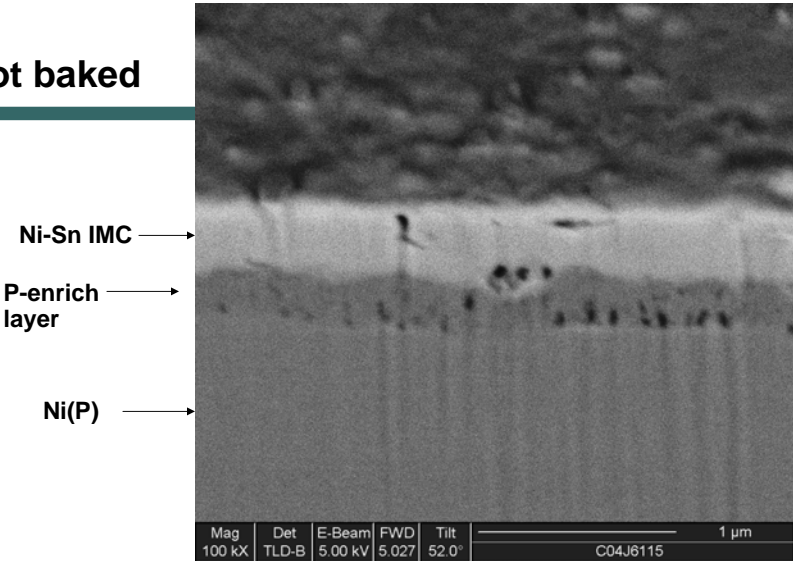
Not baked

The voids are present at the package side (ENIG) before the baking, similarly reported by Goyal et al (ECTC 2002). But the voids at PCB side (OSP Cu) are not before the baking.

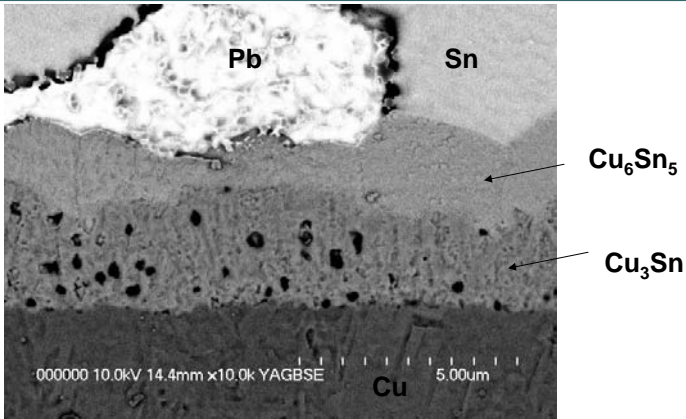
Same type BGA shown previous slides, but with SOP finish, attached to motherboard with OSP pads, baked 20 days @ 125°C, **board side**

-Sample was lightly etched by Ar ion to remove the surface layer due to polish. A quick and low cost method than FIB.

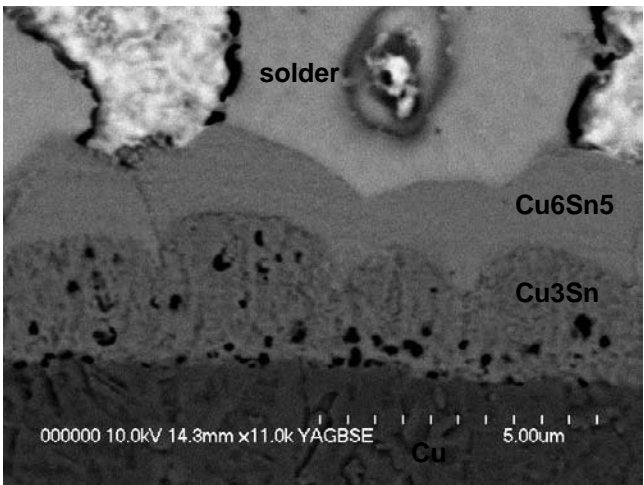
- Not all voids are aligned at the Cu₃Sn / Cu interface, some are at interior of Cu₃Sn, different from Chiu and Date

- Cu₆Sn₅ and Cu₃Sn have the same wave pattern

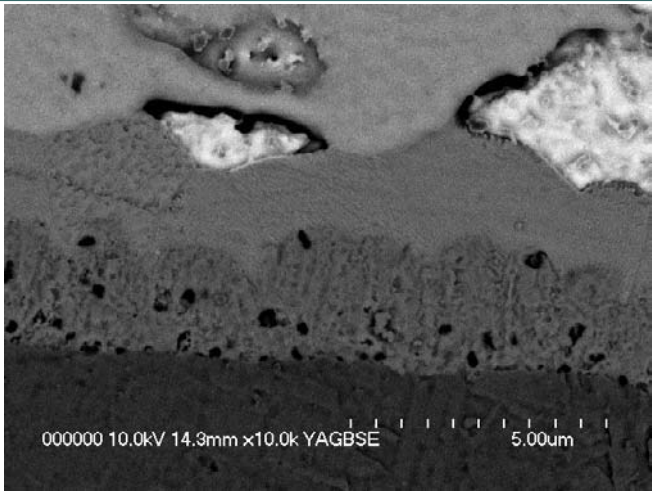
BGA from NEC with SOP Finish Attached to Motherboard with OSP Pads, Baked 20 days @ 125°C, **Board Side**

In Chiu's paper, voids at the interface reached 70% of the joint interfacial area after 20 d @ 125°C. Here at most, 30%. Considering three dimensions, the voided area may be only 9%.

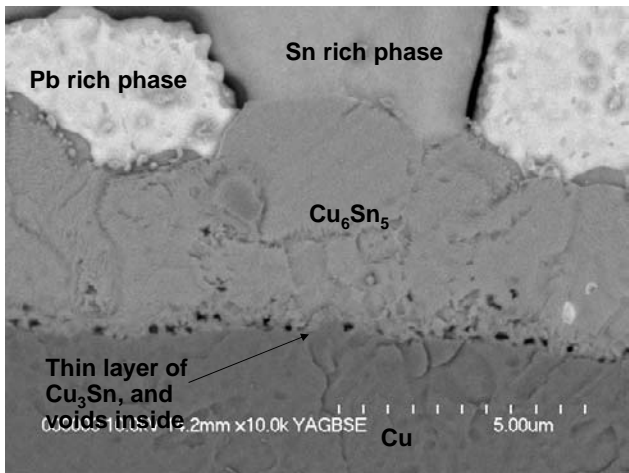
Same joints as in the previous slide, **package side: SOP**

On the package side, the Cu₃Sn layer is very thin. Fewer voids, confined within the Cu₃Sn layer.

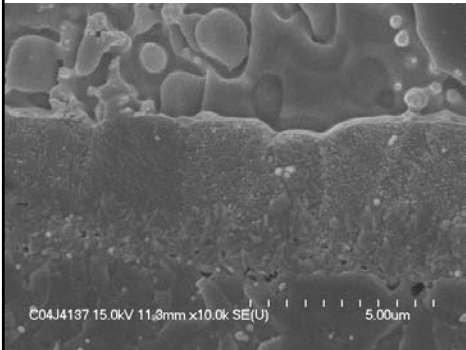
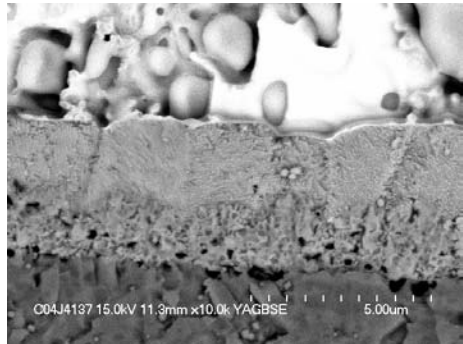
Sn-Pb bump on Laminated Cu (not Electroplated), Baked
20 days @ 125°C

Yang et al (J. Electronic Mater., Vol. 23, (1994), reports that voids occur only in electroplated Cu, not in cold rolled Cu. Here we have a laminated Cu (non-electroplated). We see voids . Also voids are better seen in backscattering electron image than in 2nd electron image, as shown here.

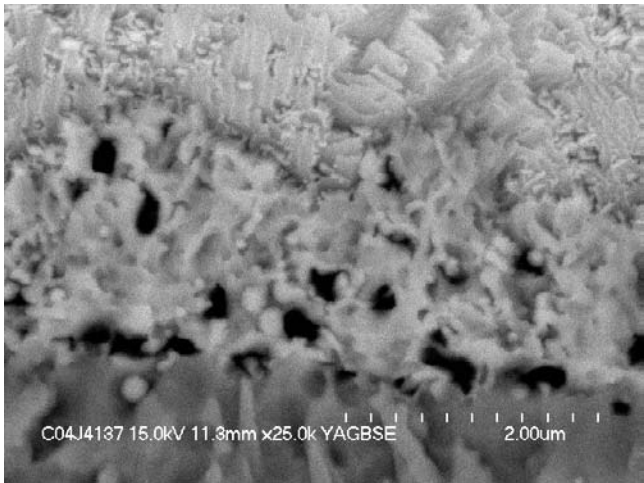
Zoom in, backscattering electron image. The sample is over-etched

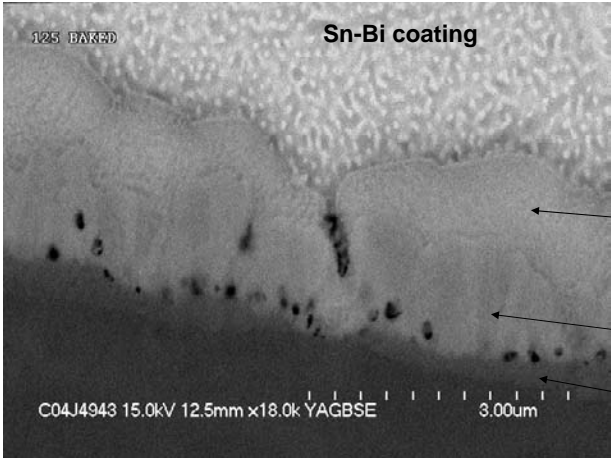
Alloy 42 lead, coated 2 μm Cu, plated Sn-1Bi solder. Baked 5 days @ 145°C

1. Voids are seen in Cu_3Sn

2. Cu_3Sn and Cu_6Sn_5 are 1.5 μm thick each.

3. There seem some residue Cu left

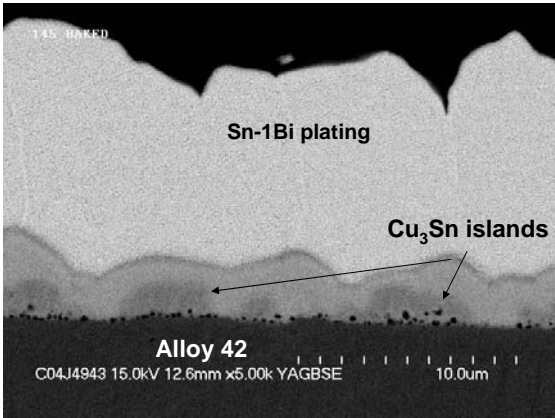
Alloy 42 lead, coated 2 μm Cu, plated Sn-1Bi solder. Baked 5 days @ 145°C

1. Voids are exclusively inside Cu_3Sn .

2. Cu_3Sn appears as islands, usually it is a continuous layer. It may be due to the limited supply of Cu.

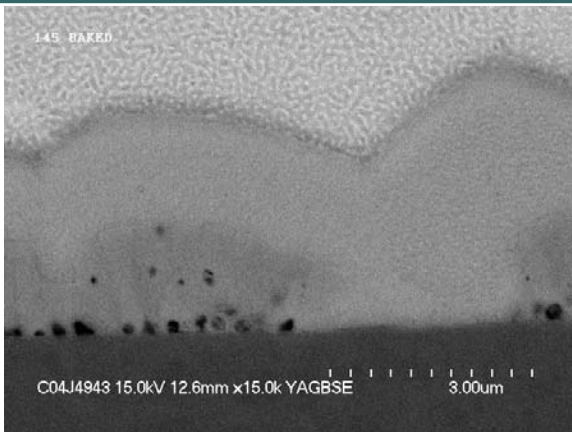
Alloy 42 lead, coated 2 μ m Cu, plated Sn-1Bi solder. Baked 5 days @ 125°C

Voids are only present inside Cu₃Sn islands. See here, there is no voids outside the Cu₃Sn islands.

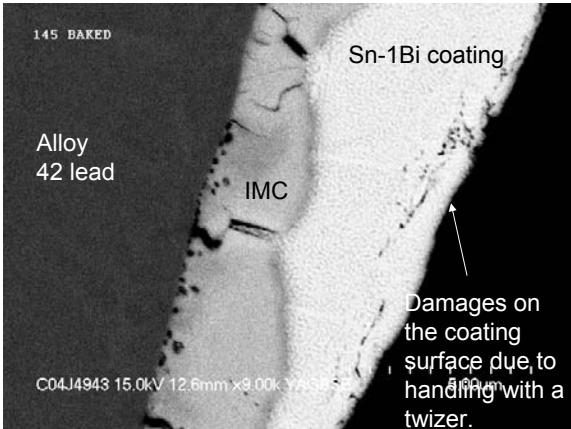
Alloy 42 lead, coated 2 um Cu, plated Sn-1Bi solder. Baked 5 days @ 125°C

This photo shows cracks inside the IMC due to handling. The cracks started from the voids inside Cu_6Sn_5 , and extended through Cu_6Sn_5 , and stop at the Cu_6Sn_5 / Sn-1Bi coating interface.

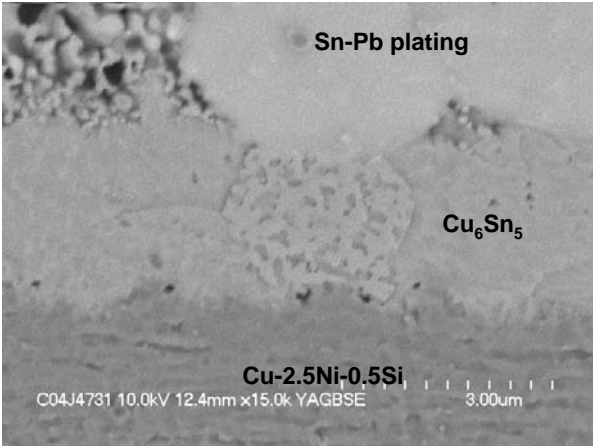
Exactly the same component, but it is Sn-Pb Coated Cu Alloy Lead, 5 days at 145°C

Very few voids at the interface.
The interfacial intermetallic is mostly Cu_6Sn_5 , Very thin Cu_3Sn layer.
There are minor Ni composition in IMC.

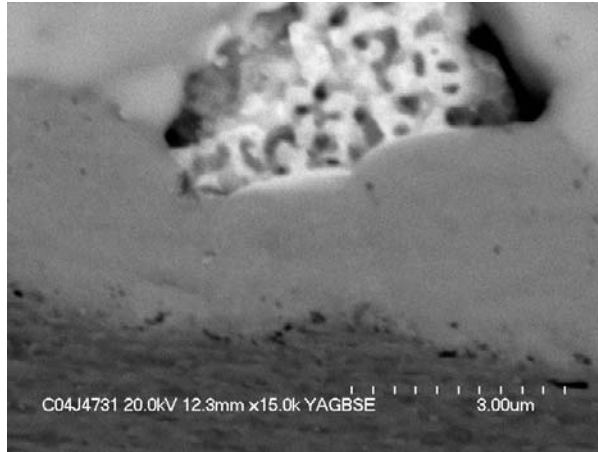
Sn-Pb Coated Cu Alloy Lead, 5 days at 145°C

Very few voids at the interface, also Cu_3Sn is not visible

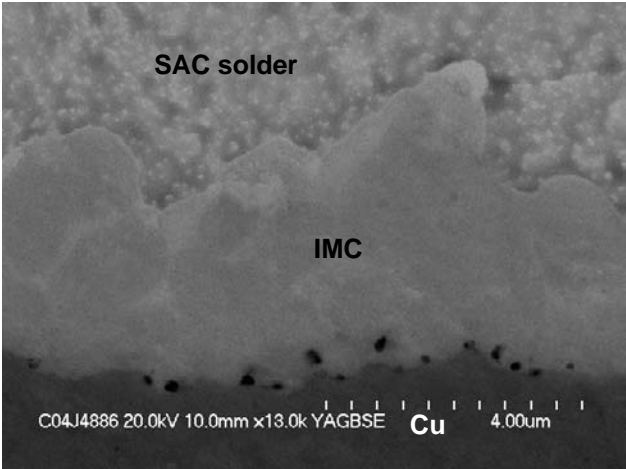
OSP / SAC solder / Electrolytic Ni, -25C ⇔ 125C, 2000 cycles, OSP / SAC side

- Here, voids are seen in thermal cycling condition, previously voids were reported in isothermal baking.
- Two shades at the interface are two IMCs

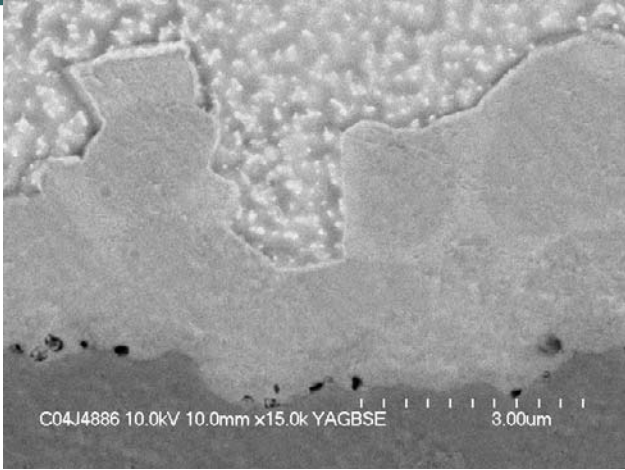
The temp profile had a 5 min ramping from -25°C to 125°C, 15 min dwell at 125°C, 5 min ramping to -25°C. The accumulated time at 125°C in 2000 cycles is about 20 days. Chiu's data suggests a 70% voided area.

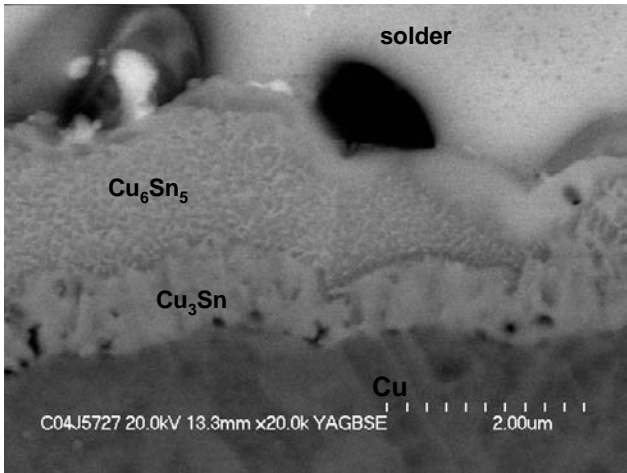
Matte Sn over Cu-3Ni lead, attached onto motherboard (OSP), -40 ⇄ 125°C, 500 cycles, **board side**

- Voids and Cu₃Sn are present on the board pads
- Couldn't detect any Ni in Cu-Sn IMC.

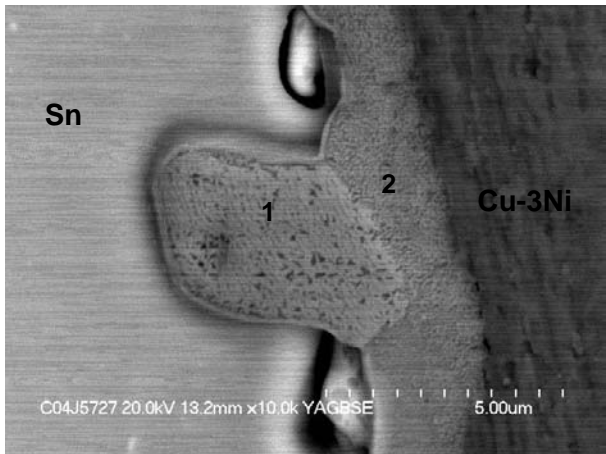
Matte Sn over Cu-3Ni lead, attached onto motherboard (OSP), -40 ⇄ 125°C, 500 cycles, **lead side**

- Neither voids nor Cu₃Sn on the lead side
- Area 1: 57.7 at%Cu, 43.3 at% Sn
- Area 2: 54.7 at%Cu, 1.2 at% Ni, 44.1 at% Sn

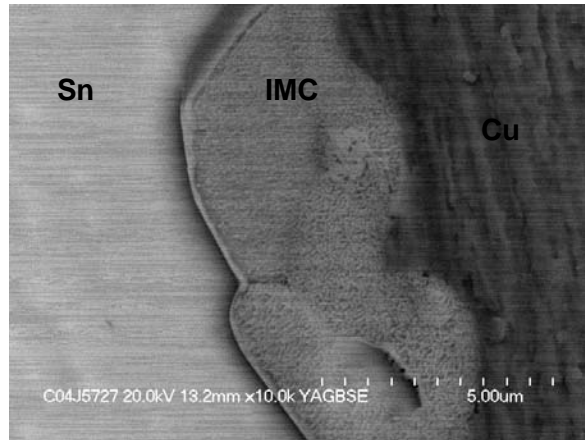
Matt Sn over Cu-3Ni lead, attached onto motherboard (OSP), -40 ⇌ 125°C, 500 cycles, lead side

The Ni atoms in the lead frame suppress the formation of Cu_3Sn , and therefore the formation of voids.

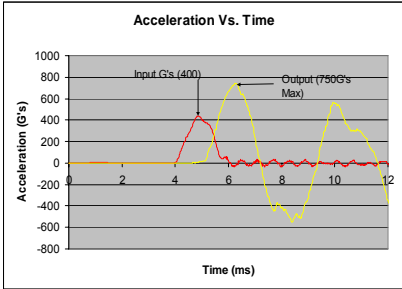
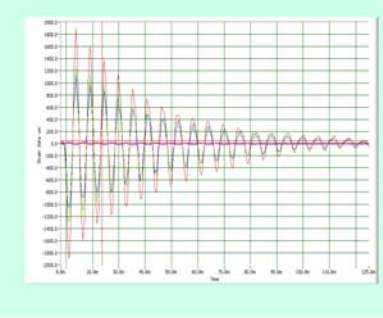
Acceleration and Strain Response

Max. Principal strain ~ 1900 us

Shock test repeated 6 times with no failures

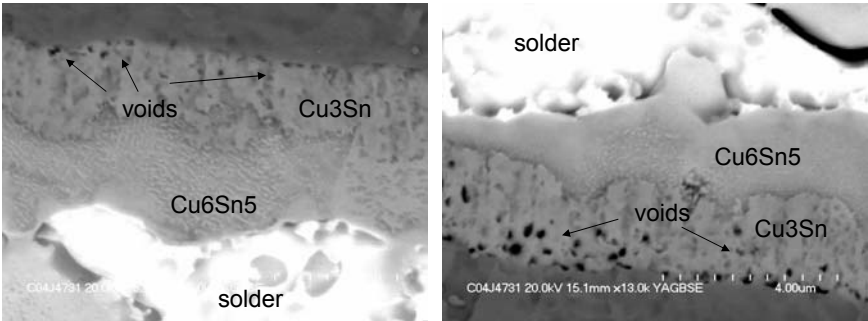
There seem more voids at the board / solder interface than at the pkg / solder interface

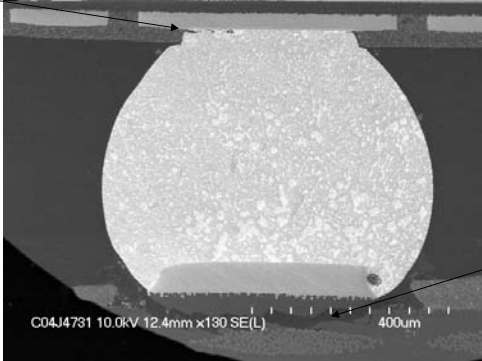
Cracked inside solder, close to the solder/pad interface

Delaminated under the pad, resin/glass interface

Cracked at two locations: (1) Pad on the motherboard side, delaminated at the glass / resin interface. (2) inside solder close to IMC at pkg side, in the solder mask defined area.

The vast amount of voids in IMC at the board side are not the weakest links in the shock

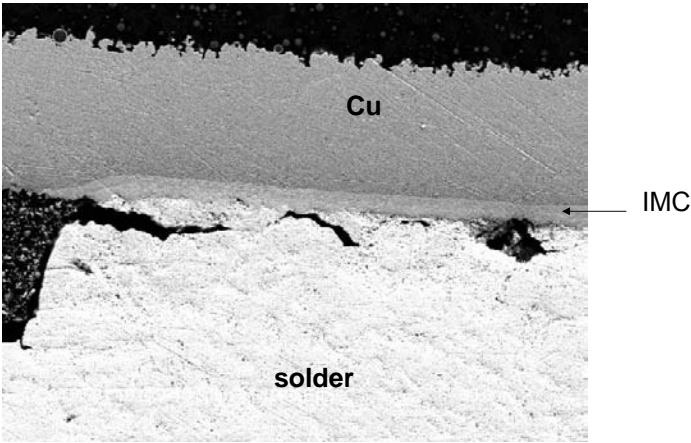
Crack within solder, not in IMC. The crack path is preferentially at boundaries between Sn-rich phase and Pb rich phase.

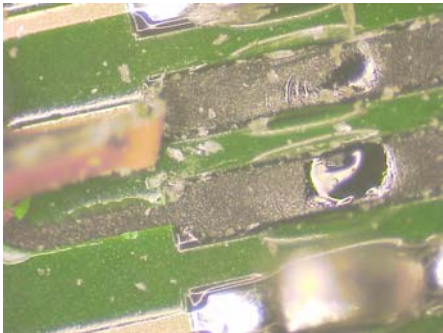
As-soldered, pad peeled off

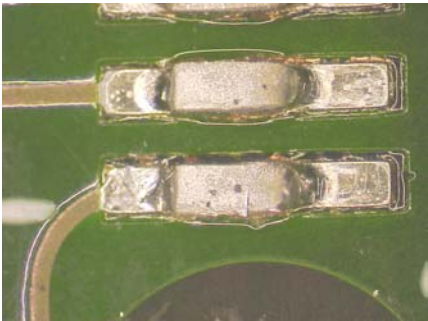
After ATC, pulled at the interface of solder / lead

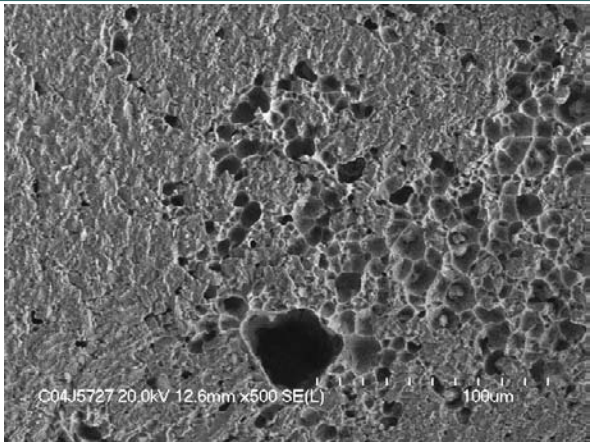
Toe side, interfacial fracture

Lead side, dimples

As shown in previous slides, the voids are present at PCB/solder interface, not at lead/solder interface. But the failure here occurred at the lead/solder interface.

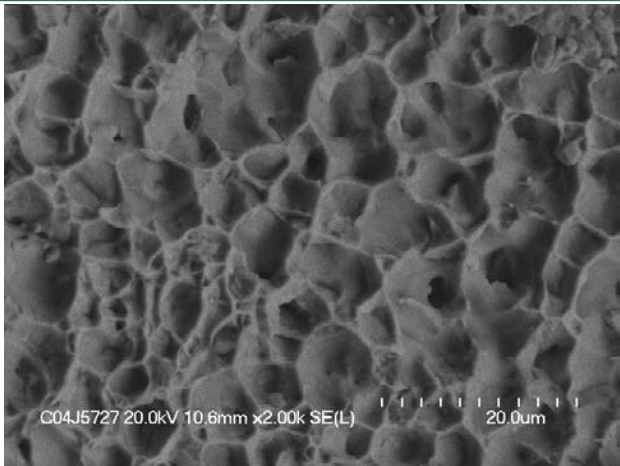
Dimples, classic plastic deformation

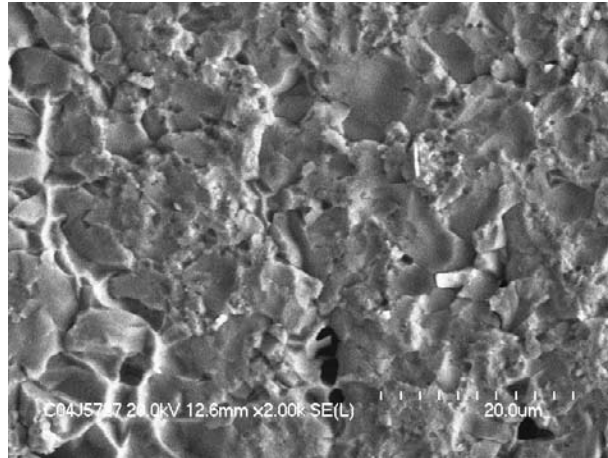
Brittle interfacial fracture at the interface between lead and solder
Fracture surface: 55.2 at% Cu, 1.2 at% Ni, 44.6 at% Sn => Cu_6Sn_5
