CERN Press Release: Analysis of LHC Incident

Summary of the Analysis of the 19 September 2008 Incident at the LHC

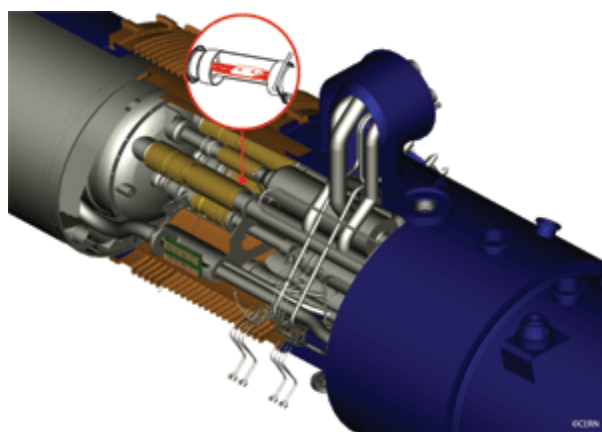
Fig. 1. Investigations have shown that a faulty electrical connection between two magnets (shown in red) was the cause of the incident in sector 3-4 of the LHC on 19 September, 2008.

On 19 September 2008, during powering tests of the main dipole circuit in Sector 3-4 of the LHC, a fault occurred in the electrical bus connection in the region between a dipole and a quadrupole, resulting in mechanical damage and release of helium from the magnet cold mass into the tunnel. Proper safety procedures were in force, the safety systems performed as expected, and no-one was put at risk.

1. During the ramping-up of current in the main dipole circuit at the nominal rate of 10 A/s, a resistive zone developed leading in less than one second to a resistive voltage of 1 V at 9 kA. The power supply, unable to maintain the current ramp, tripped off, and the energy discharge switch opened, inserting dump resistors into the circuit to produce a fast current decrease. In this sequence of events, the quench detection, power converter and energy discharge systems behaved as expected. Prior to this fast discharge, it is certain that a magnet quench can be excluded as the cause of the initial event. During the discharge, many magnet quenches were triggered automatically in the arc and the helium from their cold masses was recovered through the self actuated relief valves.

2. Within one second, an electrical arc developed, puncturing the helium enclosure and leading to a release of helium into the insulation vacuum of the cryostat. After 3 and 4 seconds, the beam vacuum also degraded in beam pipes 2 and 1, respectively. Then the insulation vacuum started to degrade in the two neighbouring subsectors*.

D - Once all possible inspections are completed, an analysis of the events will lead to recommendations for future actions to prevent the reoccurrence of this type of initial event, and to mitigate its consequences should it accidentally reoccur. Although the cause of the initial growth of connection resistance has not yet been established, and knowing that a similar event has not occurred in the test of all other sectors and of their thousands of connections, it has nonetheless been decided that additional measurements to generate early warnings and interlocks, improvements in pressure relief devices and in external anchoring of the quadrupole cryostats with vacuum barrier will be implemented before any further powering of the LHC circuits at high current.
