# Why AC transformers “Complain” Noisily About DC Current

# New Moraga Sub Bank #3

- ◆ 230kV/115kV
  - 1 phase auto
  - core form
  - 134MVA per phase

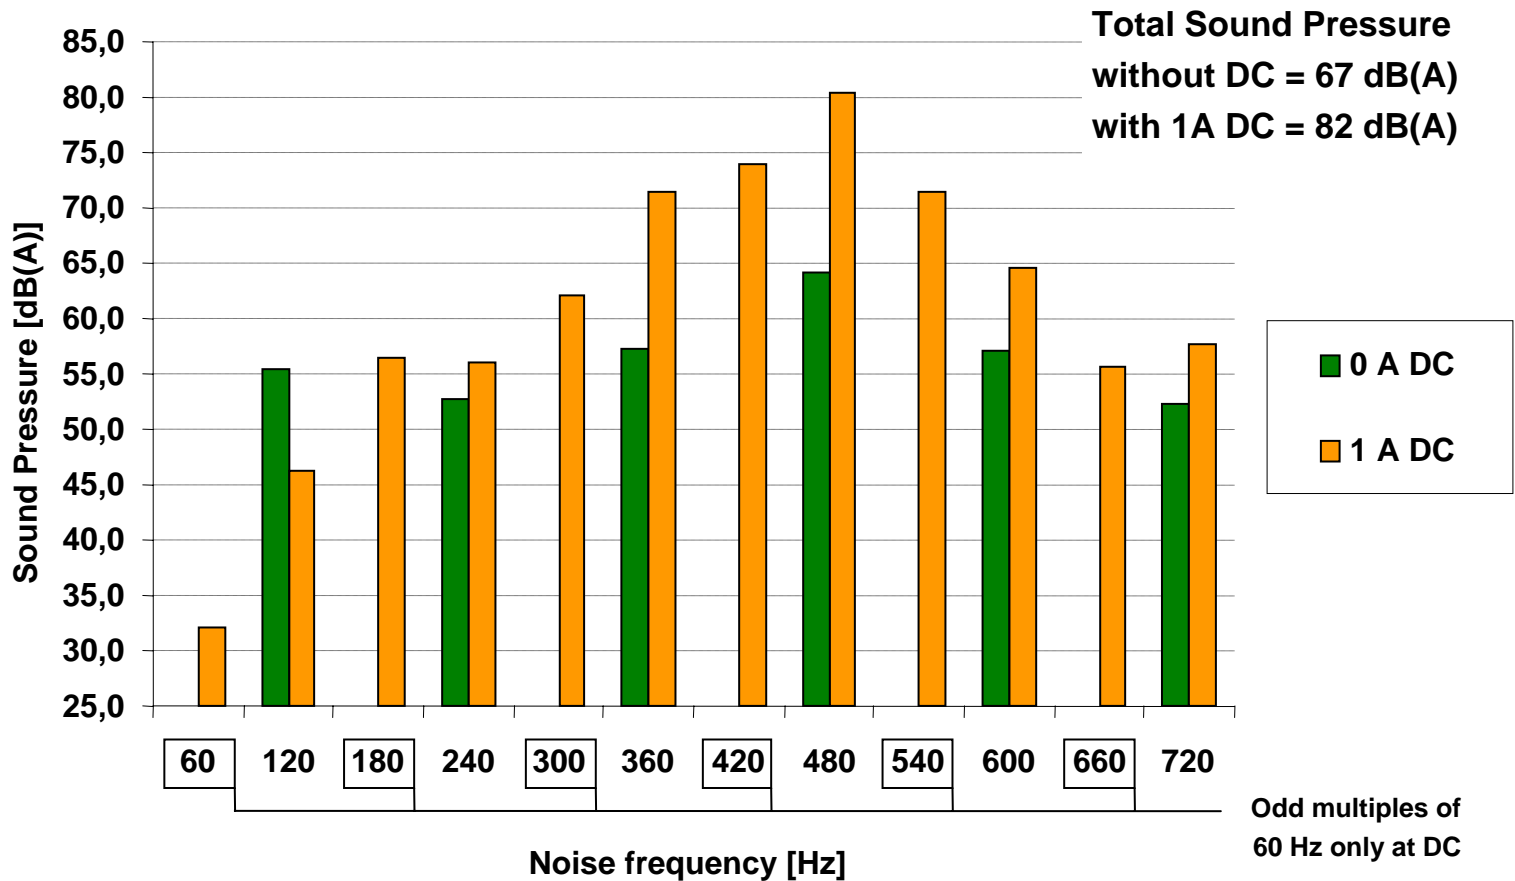
# Sound Pressure Harmonics with and without DC Current

## 134 MVA Single Phase Transformer (B<sub>core</sub> rated AC = 1,73 T)

- ◆ Not typical 120 Hz hum
- ◆ Bank #3 has “Buzz” at 300 Hz and higher
- ◆ Produces up to 85dB(A) and varies throughout day
- ◆ Transformer was designed to be 76dB(A) or less and stay out of saturation.
- ◆ Transformer at factory tested at 66dB(A) at .3 m distance w/o fans

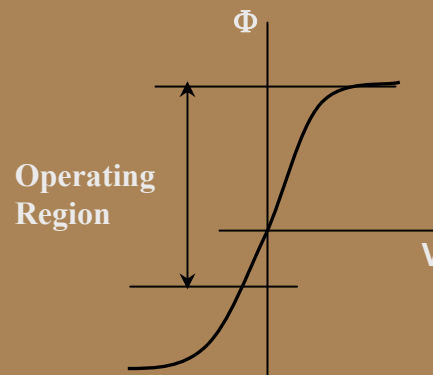
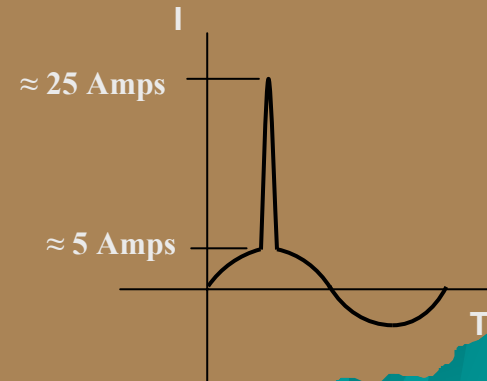
Xfmr  
With DC

- ◆ We believed the high noise was being caused by DC current, but didn't know how to stop DC.
  - The dc current causes offset flux in the core and partial (1/2 cycle) saturation.
  - Same as GIC effect on transformers.
- ◆ Through switching tests, primary source of dc current was isolated to 115kV source.

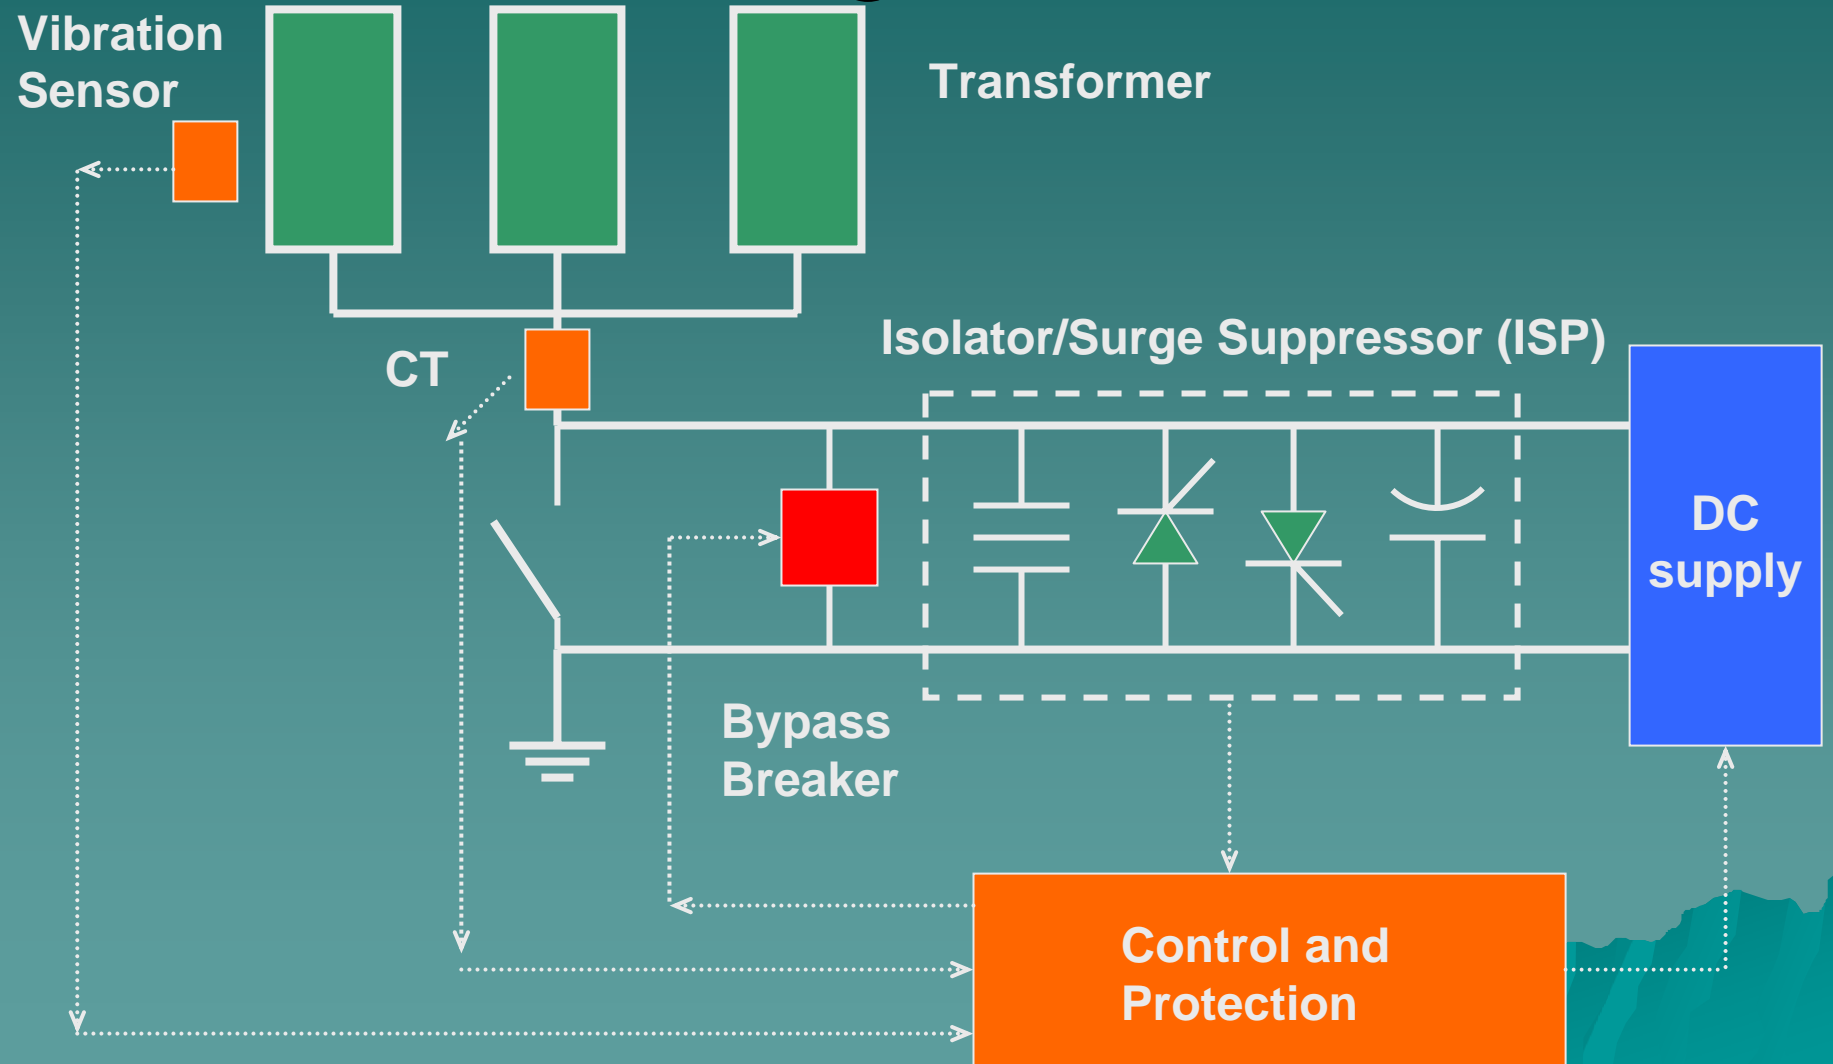
# FOC Simplified One-Line Diagram

- ◆ **ISP** – Isolator / Surge Protector: Commercially available self-protected capacitor, 88 mΩ, 18 V breakover.
- ◆ **Power Supply and Polarity-Switching** 10 A max. Voltage or Current Controlled
- ◆ **Bypass Breaker:** Single-pole vacuum switches
- ◆ **Vibration Sensor**
- ◆ **Controls and Protection:** GE-N60 Programmable Relay

- ◆ Uses a low-ohm capacitor to pass ac current but block dc current in the neutral
- ◆ Detects when system dc current has caused offset flux to create transformer vibration
- ◆ Injects approx. 4 A dc current into neutral of bank and “pushes” flux back out of the saturation region
- ◆ Virtually all injected current is expected to stay in Moraga Substation and return to the controller via the ground mat.

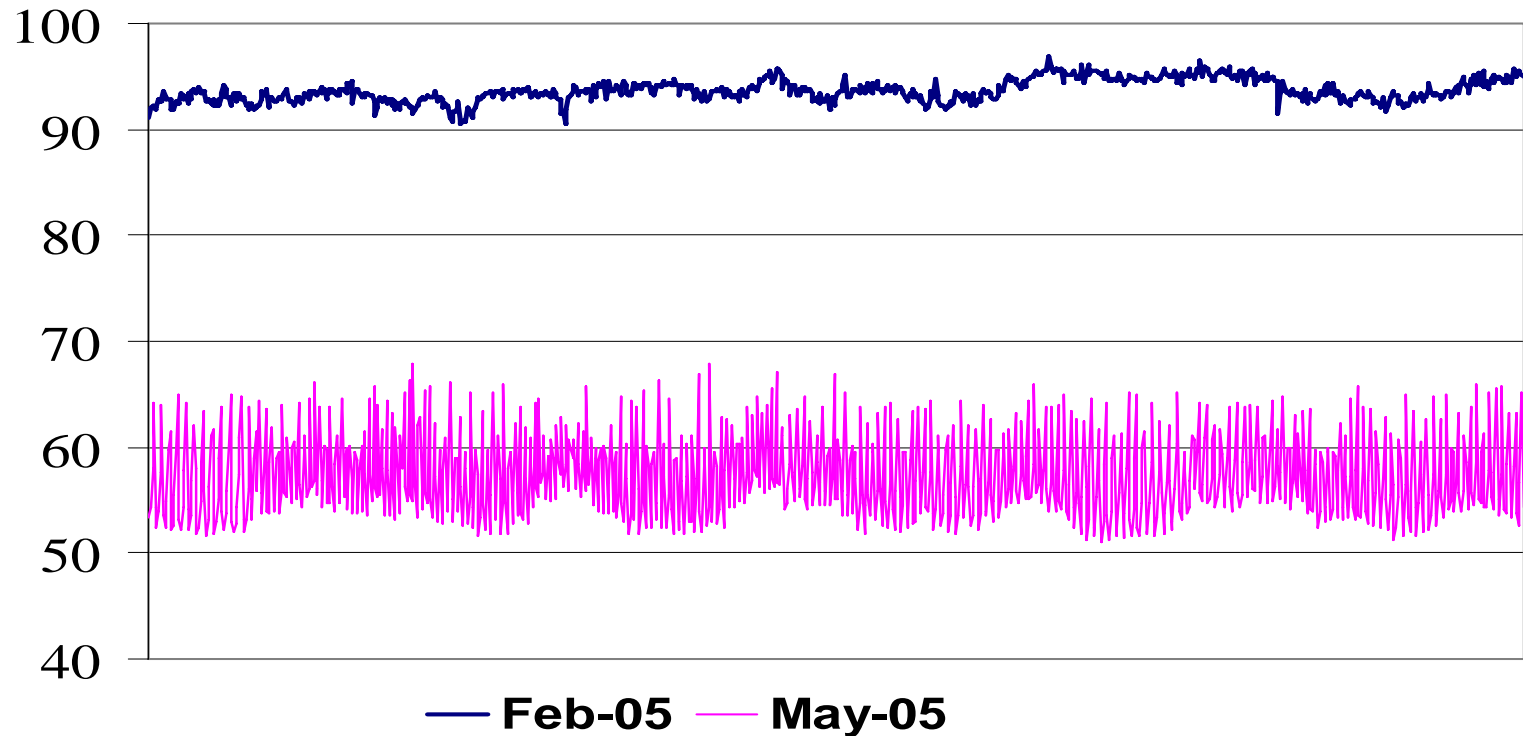
# Sno-king Bank Vibration Before & After FOC

**db A - vs - Time**  
**5-min SCADA Data for 3 Days**
