A Chemical and Electrical Analysis of Aged CableCURE Rejuvenated Cables

ICC November 5th, 2007 Scottsdale, AZ

Utilix Corporation

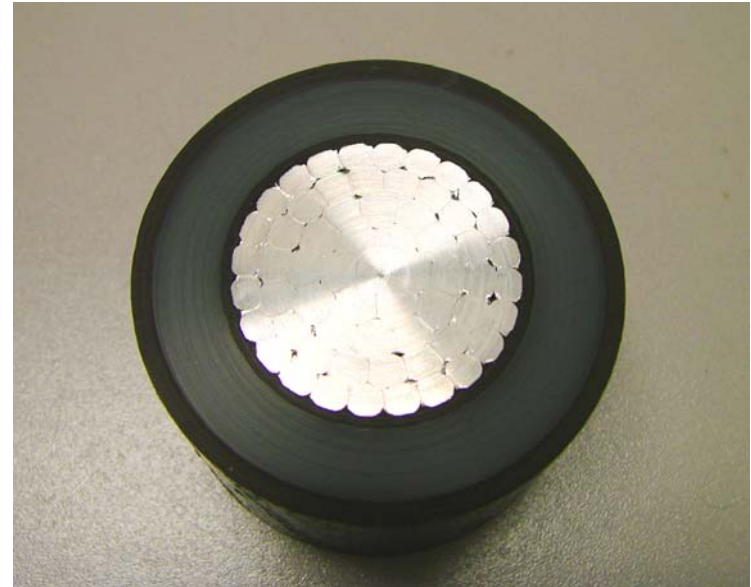
- 1000kcmil AL
(manufactured in 1973)
- 260mil XLPE insulation (35 kV rated)
- Fabric strand shield with extruded overlayer
- Bonded insulation shield
- Copper concentric neutrals
- Unjacketed

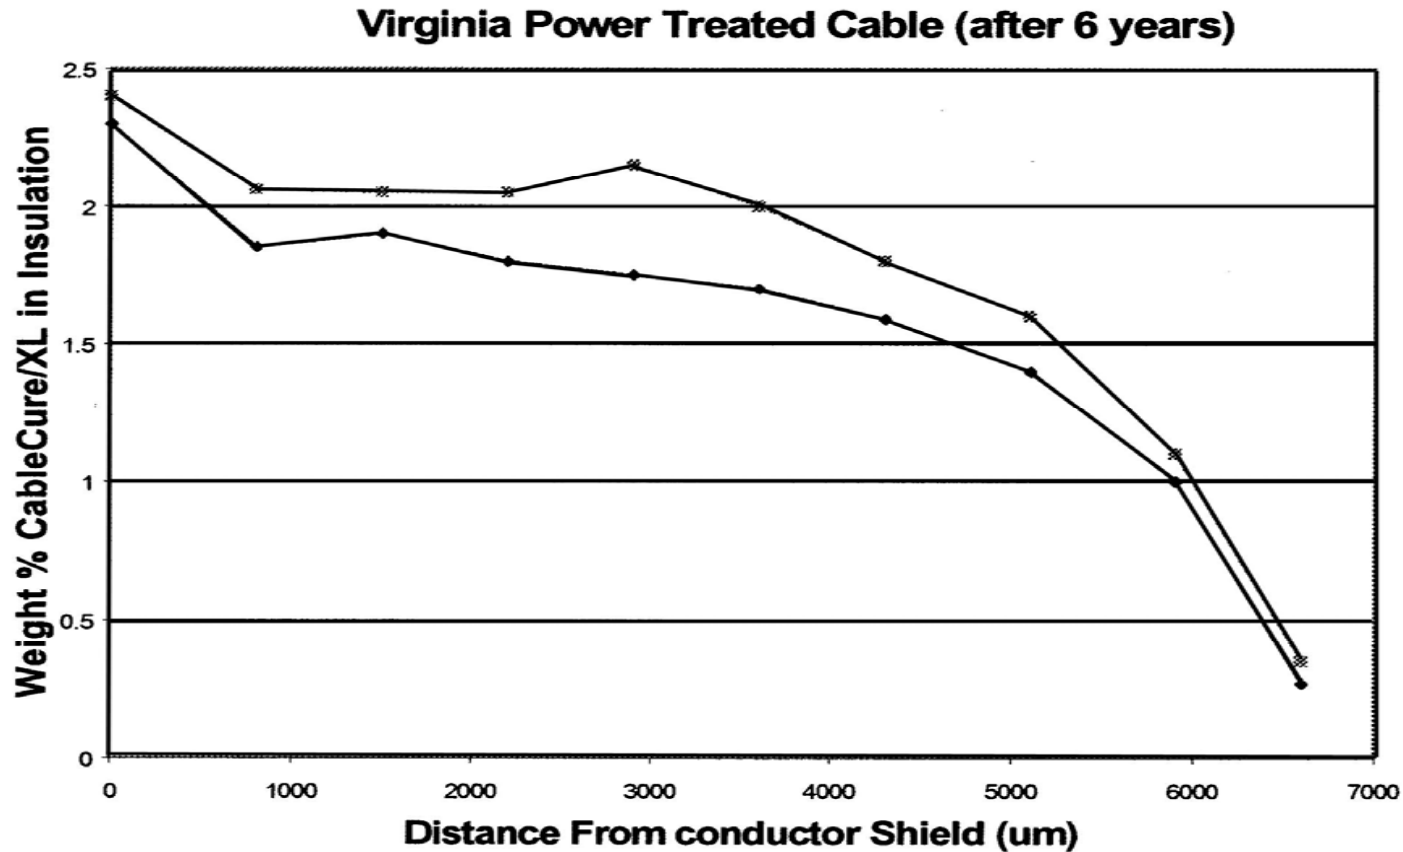
Case Study #1: Dominion Power (Micro IR 6 years after treatment)

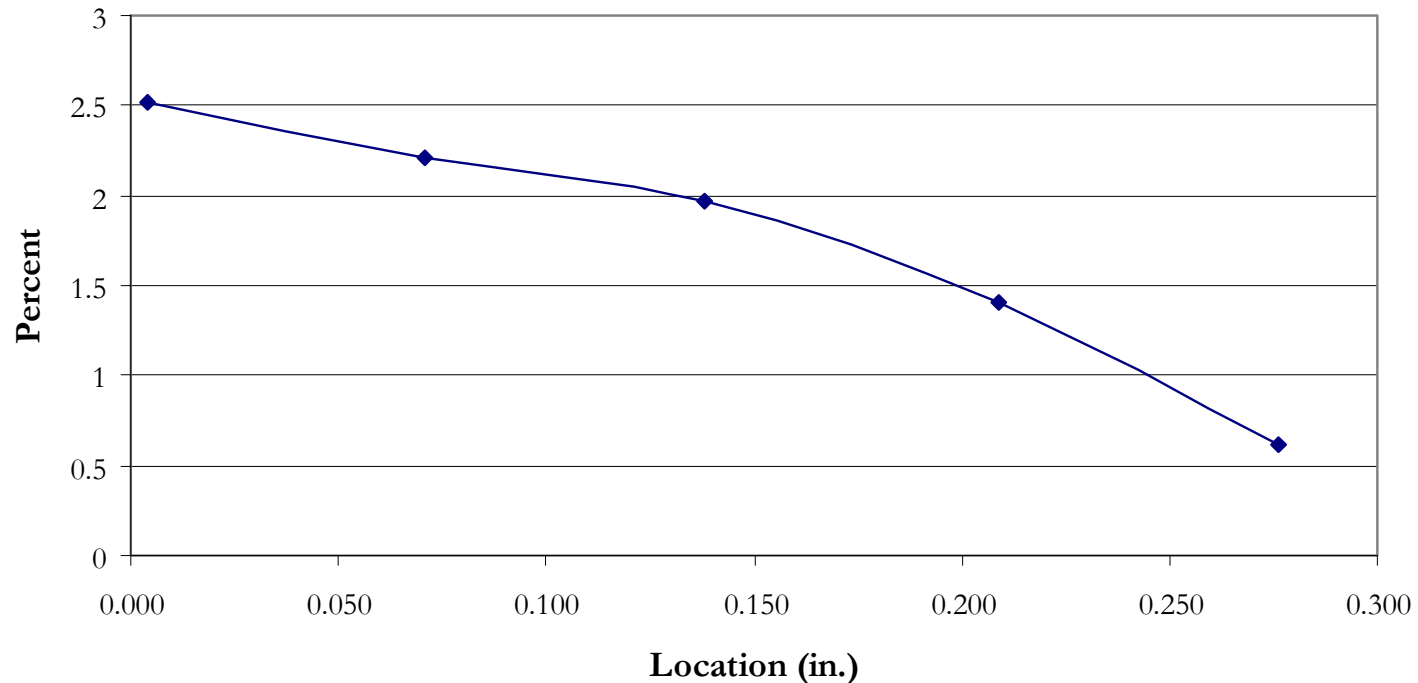
Case Study #1: Dominion Power (Micro IR 13 years after treatment)

**% PhMeSi(OMe)₂ to Polyethylene vs.
Position from I.D. to O.D.**

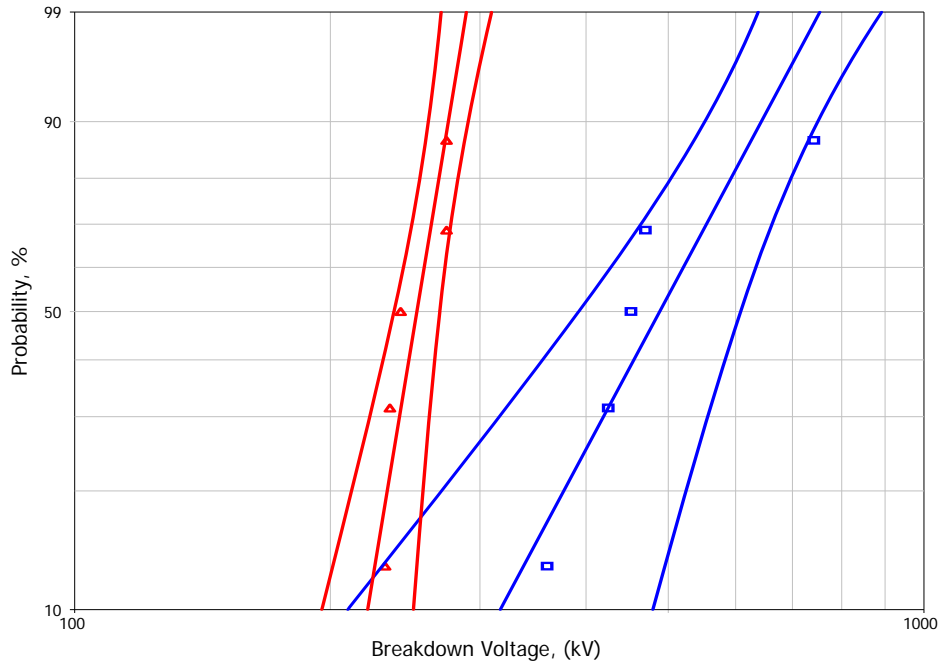
Case Study #1: Dominion Power (AC Breakdown Data after 6 years)

“What appears to be important is that vented trees growing from the conductor shield in the red (untreated) phase are significantly larger than those in the treated phases. This fact implies that injection reduced (or even stopped) the tree growth.”

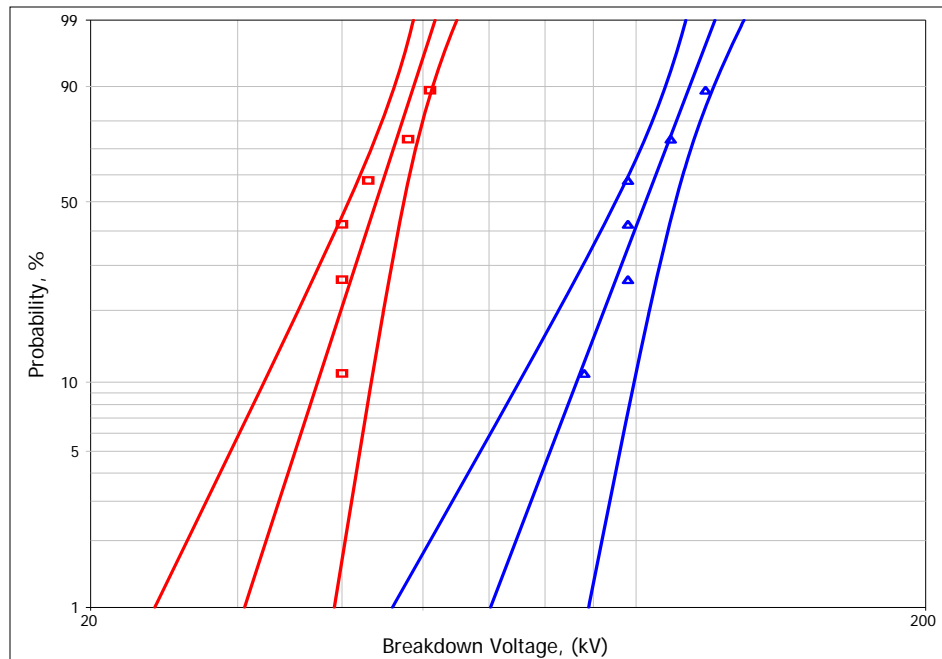
Case Study #1: Dominion Power (AC Breakdown Data after 13 years)

“Comparative evaluation of service aged cable sections – from the phase aged without treatment and from those impregnated... indicated significant improvement in the cable dielectric strength caused by rejuvenation. At present, this characteristic of the treated cable is still twice as good as that of the untreated cable.”

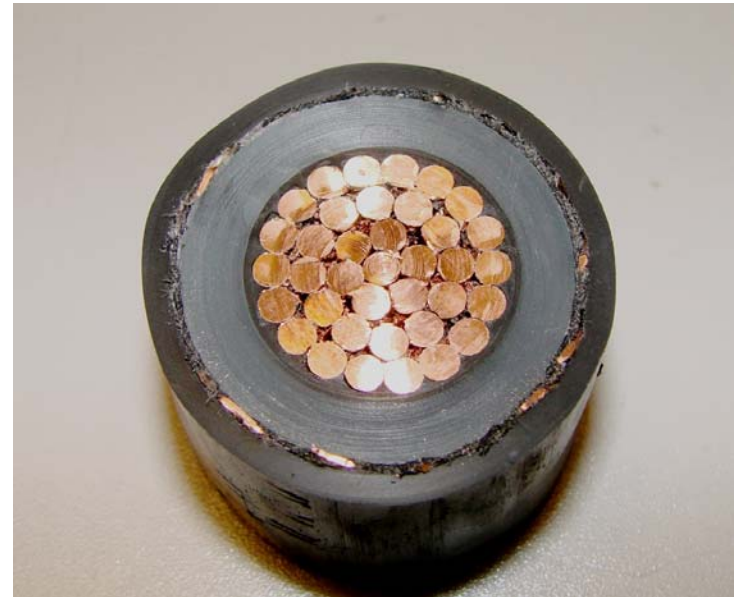
- 500kcmil CU
- Manufactured by Rome Cable (1968)
- 175mil XLPE, 15kV
- Extruded conductor shield
- Fabric insulation shield
- Copper drain wires
- Jacketed

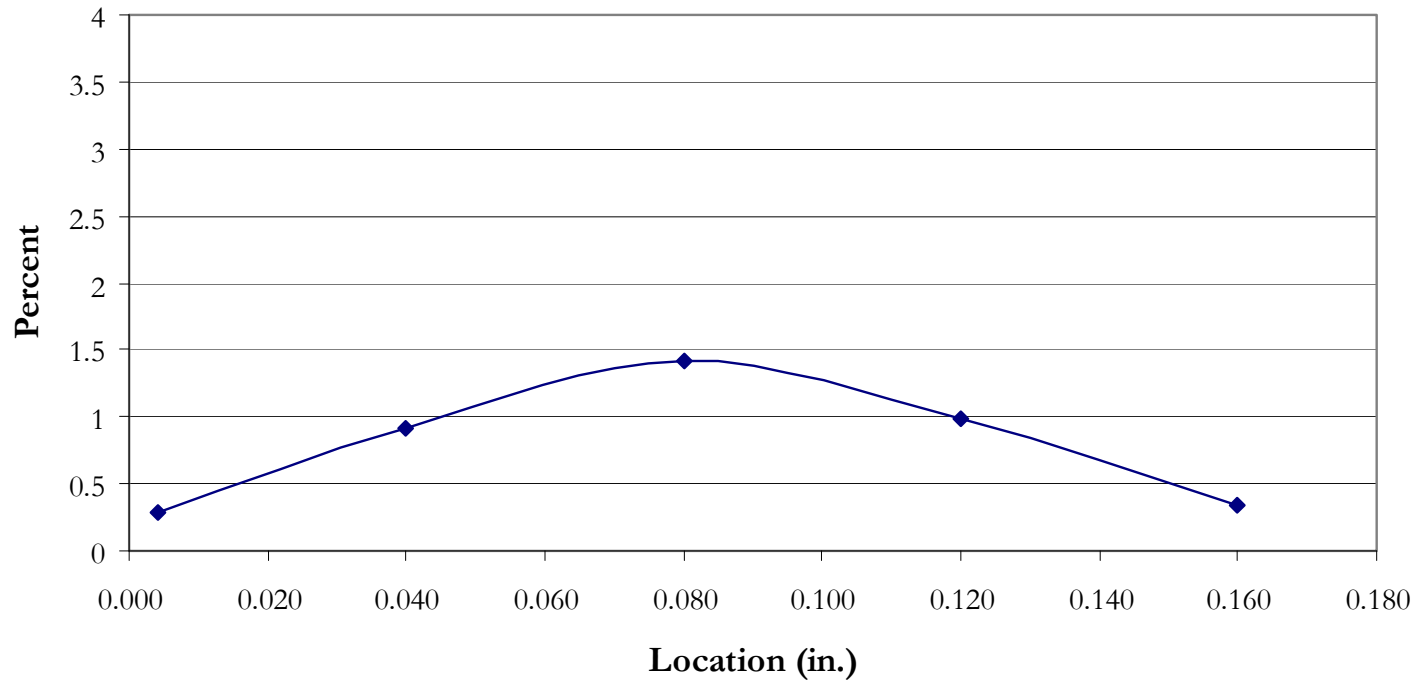
Case Study #2: Dow Corning (Micro IR 18.5 years after treatment)

% PhMeSi(OMe)₂ to Polyethylene vs.
Position from I.D. to O.D.
