Added CFO Voltage by the Fiberglass Distribution Line Pole

S. Grzybowski, *Fellow, IEEE*, and X. Li, *Student Member, IEEE*

Abstract—This paper presents the study results conducted on the critical flashover (CFO) voltages of the fiberglass distribution line pole and its combination with polymer and porcelain insulators. Special attention was made to evaluate the Added CFO voltages by the fiberglass pole to the insulators when pole served as a second component in the distribution line structure. A discussion of the results follows the data obtained.

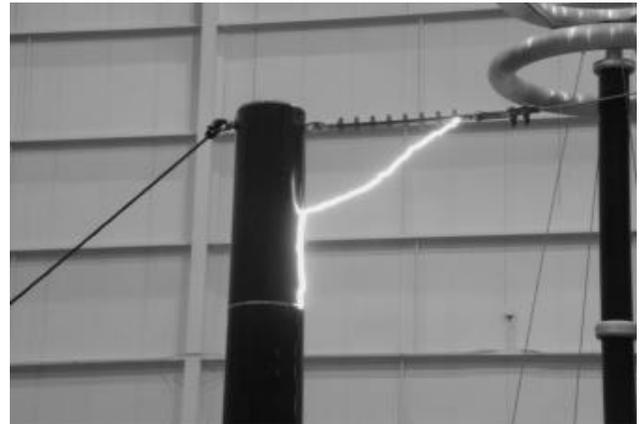
Fig. 4. The 35 kV polymer suspension insulator plus fiberglass pole, the tested pole length is 2 feet. The discharge took place in the air and on the surface of the pole.

The flashover would occur on those paths where the insulation structure exhibits the weakest impulse strength. Therefore, different flashover paths are expected to occur in the tests if combined insulation structure was evaluated. When the pole length is 1 foot, the discharge happened in the air gap,

than the air gap between the energized insulator and the grounded electrode. When the pole length was 2 feet or above, the discharge paths always initiated from energized insulator and terminated on the pole surface about 1 foot below the top of the pole though the air, then developed on the surface of the pole until the grounded electrode was reached. Some times the discharges appeared around the suspension insulator surfaces and the pole surfaces. Therefore, the lightning impulse strength of the air gap between the energized insulator and grounded electrode became higher than the surfaces of insulator and pole in this case.

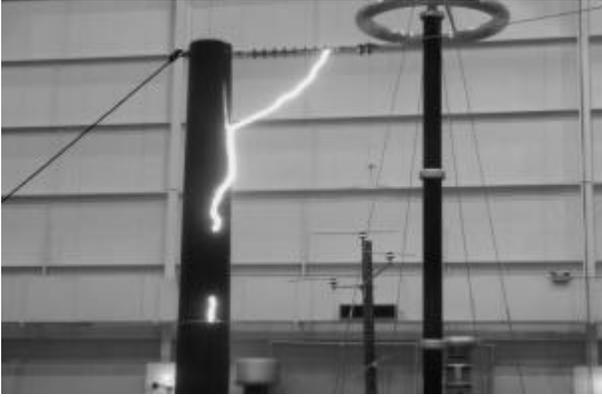
Fig. 5. The 35 kV polymer suspension insulator plus fiberglass pole, the tested pole length is 6 feet. The discharge didn't develop on the surface of insulator, but appeared in the air and on both sides of the pole's surfaces.

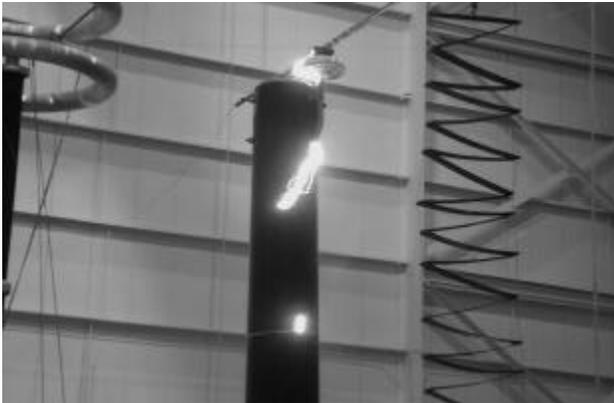
Fig. 6. The 35 kV porcelain pin insulator plus fiberglass pole, the tested pole length is 3 feet. The discharge developed on the surface of insulator and both sides of the pole's surfaces.

When the distribution line pole structure of porcelain pin insulator and fiberglass pole was tested, the discharge paths are different from those of polymer suspension insulator. In this insulation structure, the discharges initiated from the energized insulator, and is developing around the surfaces of the insulator and the pole, because the surfaces of the insulator and pole have the least lightning impulse strength.

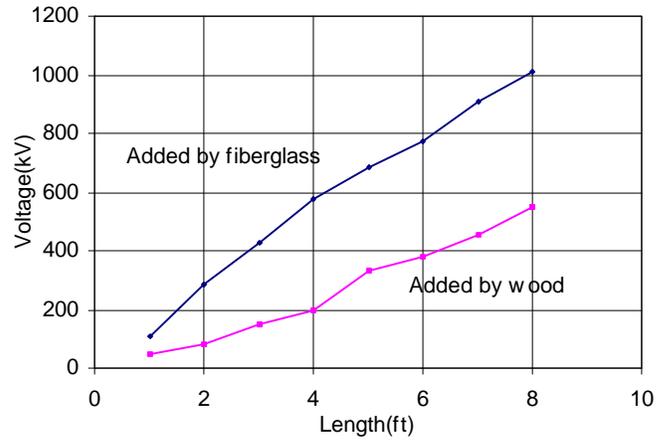
Fig. 11. The Added CFO voltages by fiberglass and wood poles to 15 kV polymer suspension insulators, wet condition and positive impulse.

From the Fig. 11, it can be found that the Added CFO voltage by the fiberglass pole is much higher than the wood pole. This indicates that the lightning impulse strength of the distribution line structure with fiberglass pole can be greatly improved if fiberglass pole is used as a second insulation component.

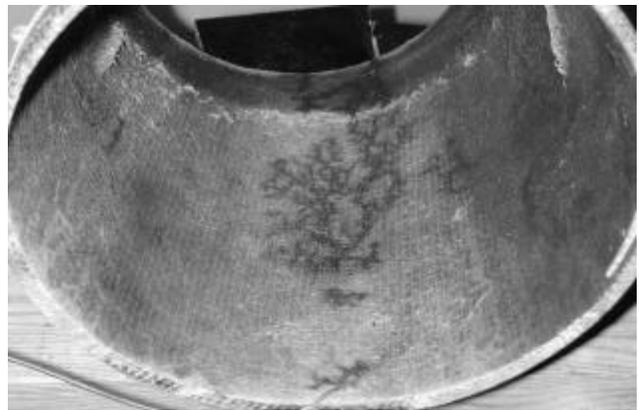
Fig. 15. The tracking appeared on the inside surface after 6.5 hours aging in salt fog with 25 kV/ft electrical stress, recorded leakage current is about 75~85 mA.

The electrical insulation strengths of fiberglass samples decreased after aging based on the results from the clean fog test and clean fog plus electrical stress tests, but the rate of degradation is very slow, especially for clean fog aging tests. It is found that the aging effect of salt fog plus 25 kV/ft electrical stress test on the insulation strengths of fiberglass material is very severe. The flashover occurred to all of the samples aged in the test of salt fog plus electrical stress in less than 10 hours. The tracking and arc trail were observed on both sides of the surfaces of these samples.

The conducted accelerated aging tests suggest that the fiberglass pole could be used in power distribution systems to improve the lightning impulse strength of distribution line structure, but should be not used in the area where salt fog occurs very frequently. The tracking on the surfaces of the samples after salt fog plus electrical stress aging test are presented in Fig. 15 to Fig. 16.
